**Re: Debtor: Chaya Sheiner**  
**U.S. Bankruptcy Court, SDNY – Case No. 16-23271(rdd)**

# YOUR Inspection Report

43 Commerce St  
Spring Valley, NY 10977

RE: Report No. 1125  
43 Commerce St  
Spring Valley, NY  
10977

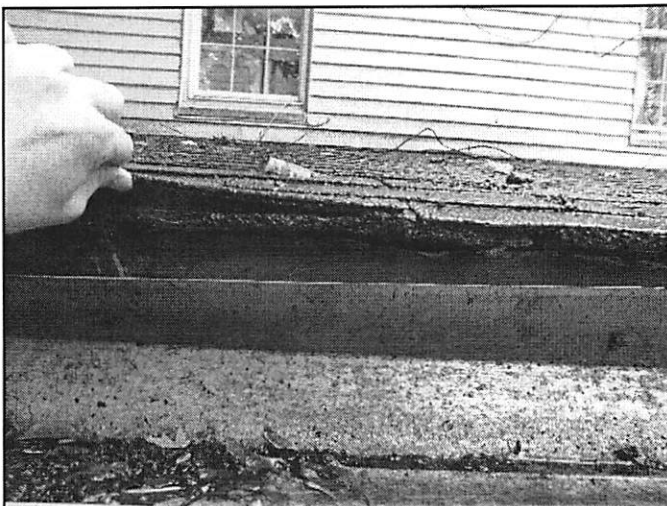
1. Rotten

**1. Condition:** • Old, worn out

Roof shingles are old, worn out with signs of buckling & roof sheathing on lower roof in the back of the house which was visible, is rotten.

**Implication(s):** Chance of water damage to contents, finishes and/or structure

Roof should be remodeled by a Licensed Roofer.

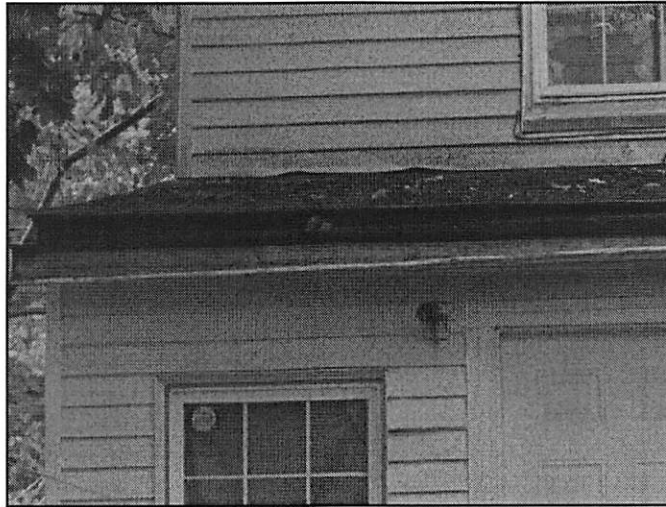
7. Damage

2. Condition: • Damage

Gutters in the back and in the front of the house are damaged and need to be replaced.

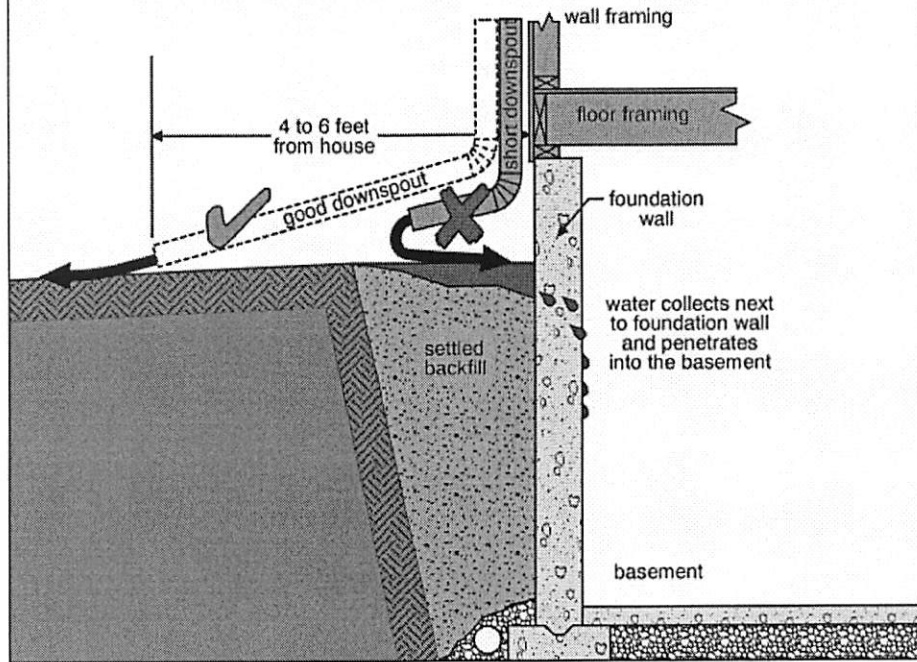
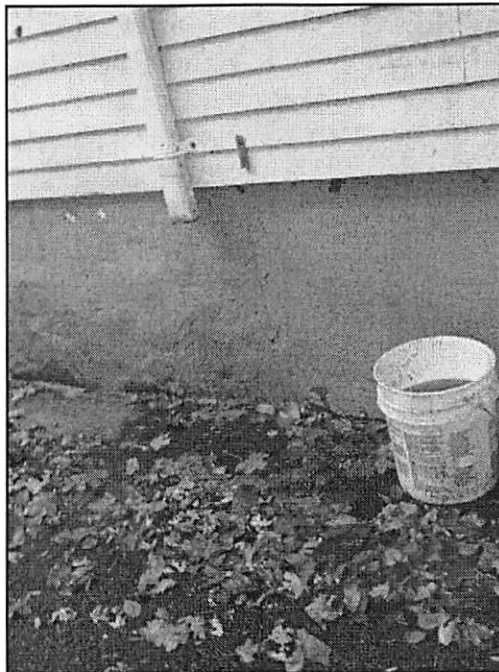
8. Downspouts discharge too close to building

3. Condition: • Downspouts discharge too close to building

Multiple downspouts around the house are too close to the house and should be extended 6 ft away.

Implication(s): Chance of water damage to contents, finishes and/or structure

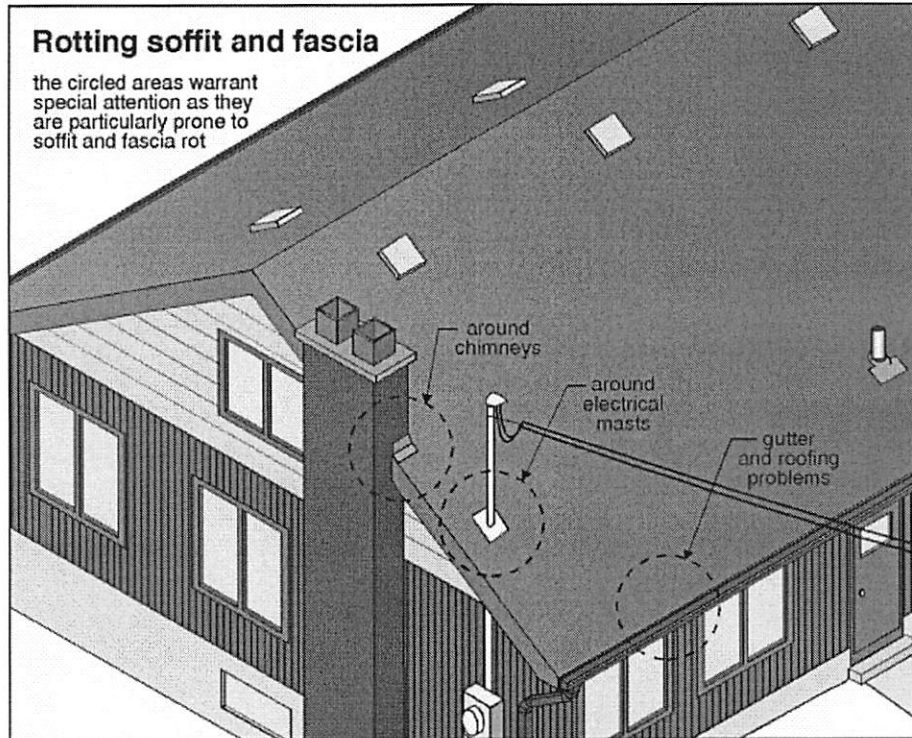
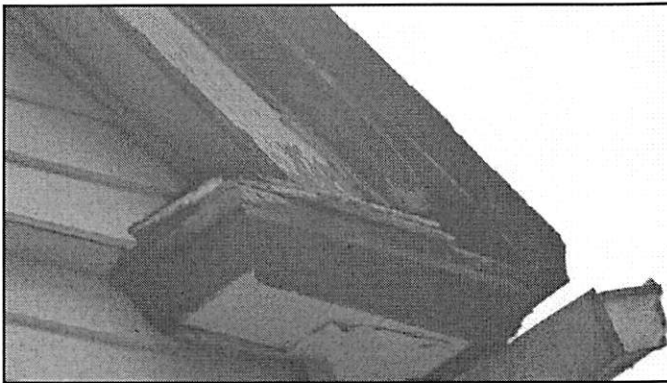
9. Rot or insect damage

4. Condition: • Rot or insect damage

Box ends of fascia on all sides are rotted & severely damaged and needs to be replaced.

**Implication(s):** Chance of water damage to contents, finishes and/or structure | Material deterioration

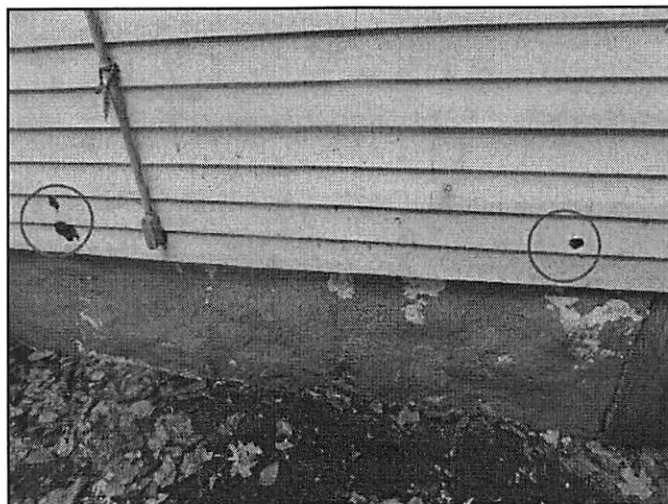
12. Damage

**6. Condition:** • Damage

Siding in the back of the house is buckled & siding on side of the house has holes.

**Implication(s):** Chance of water damage to contents, finishes and/or structure

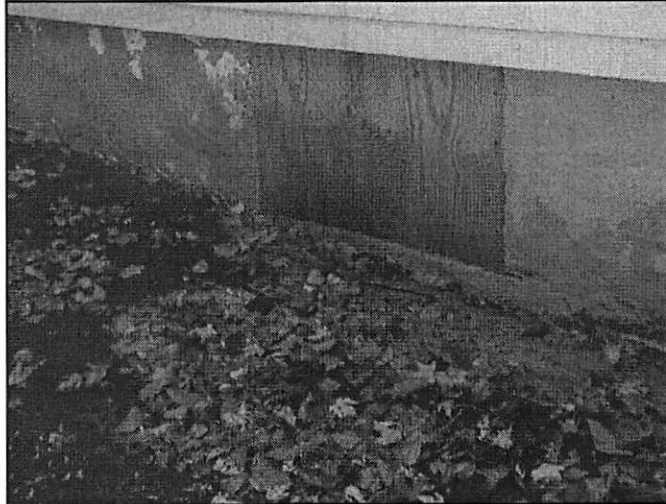
13. blocked

Basement window is blocked off with plywood and should be corrected.

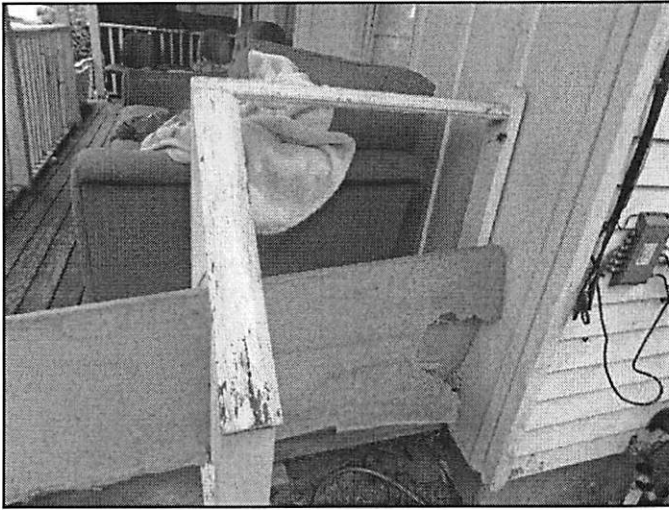
14. Missing Railing

Some railing is missing by front deck & railing is loose as well.

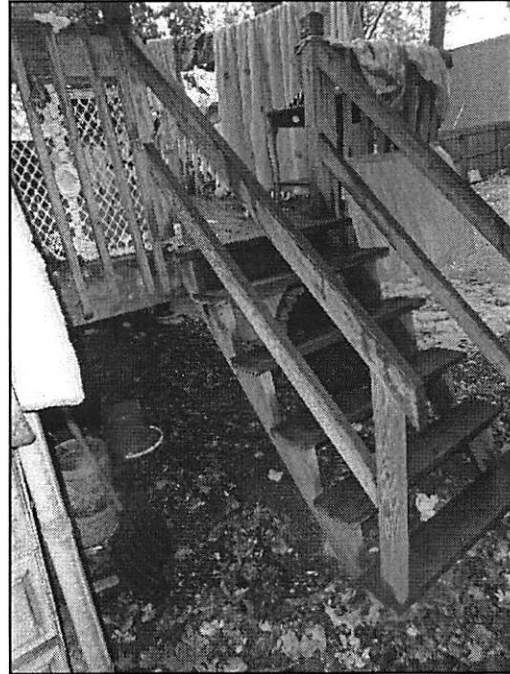
15. Weak & climbable

Spindles on steps are climbable & should be replaced.

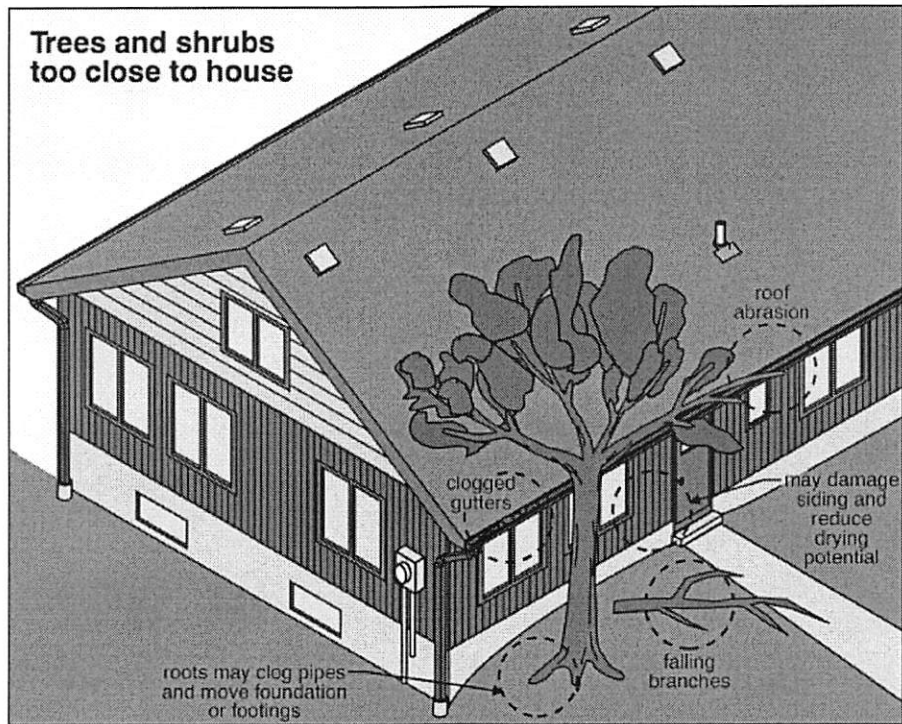
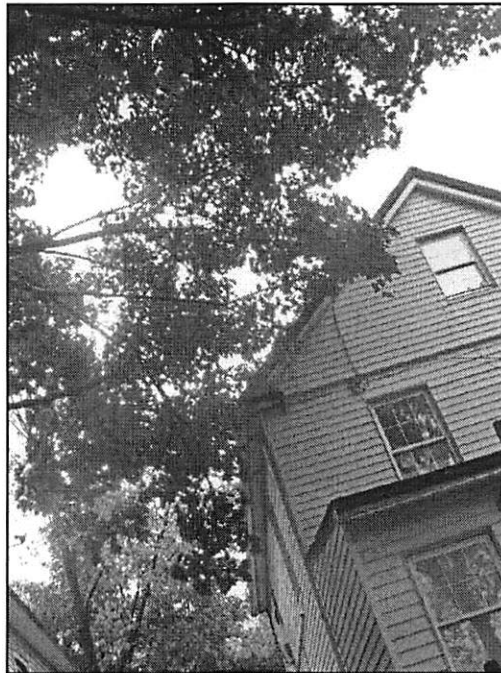
16. Overhanging trees

9. Condition: • Trees or shrubs too close to building

Implication(s): Chance of water damage to contents, finishes and/or structure | Chance of pests entering building |  
Material deterioration

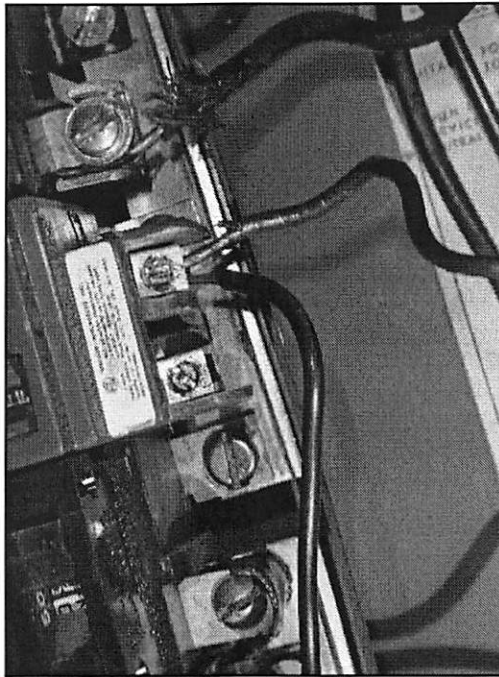
19. Double taps

11. Condition: • Double taps

Double tapping noted in the distribution panel.

Please note: Breakers are manufactured by "Pushmatic" which are not typical and may be more costly when repairs needed.

Implication(s): Fire hazard

Task: Correct by a Licensed Electrician

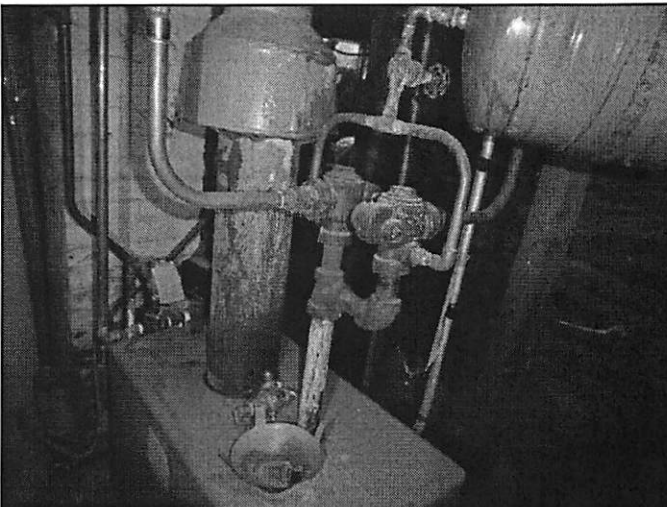
21. Rust

**15. Condition:** • Rust

Piping by the boiler area, indoor chimney vent & inside of the boiler are rusty and should be replaced.

**Implication(s):** Fire or explosion

**Task:** Correct by a Licensed Plumber

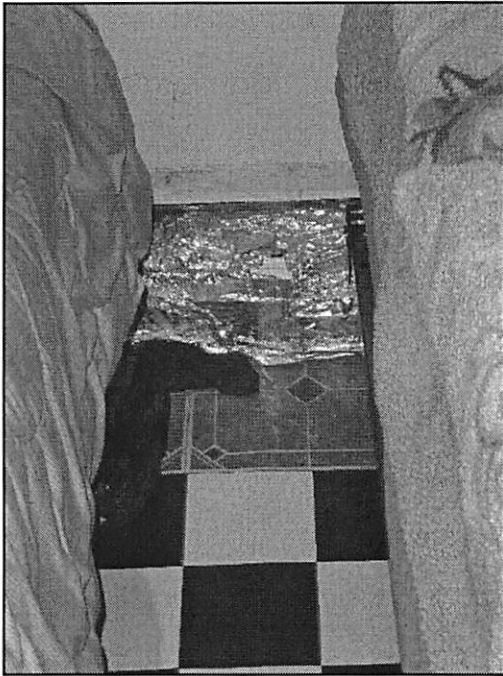
23. Baseboard

**17. Condition:** • Baseboard in one of the bedrooms are covered with foil. Foil should be removed and further investigated & corrected.

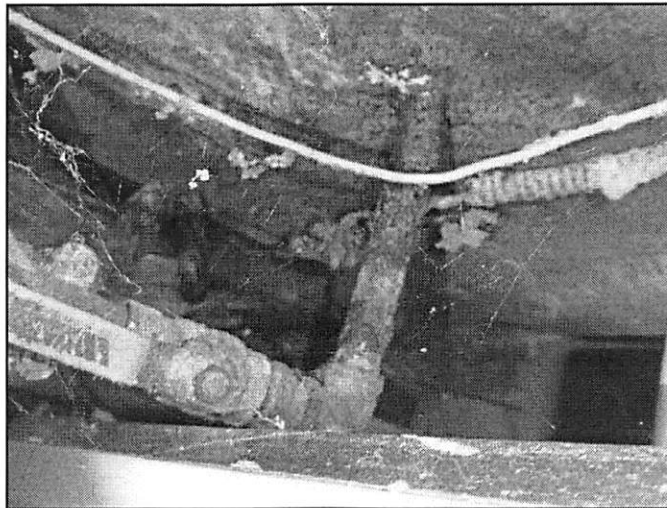
28. Leak

##### **20. Condition:** • Leak

A leak was noted by the water entry pipe and pipe is corroded and should be replaced.

**Implication(s):** Chance of water damage to contents, finishes and/or structure | Damage to equipment

**Task:** Correct by a Licensed Plumber

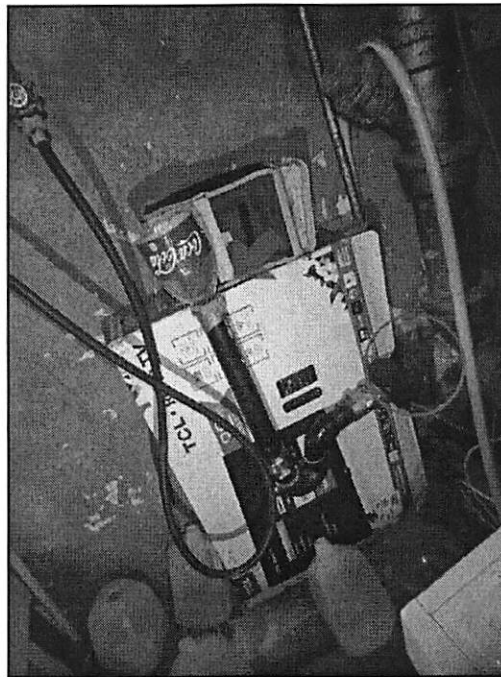
29. Nonstandard materials and patches

##### **22. Condition:** • Nonstandard materials and patches

**Implication(s):** Chance of water damage to contents, finishes and/or structure | Sewage entering the building

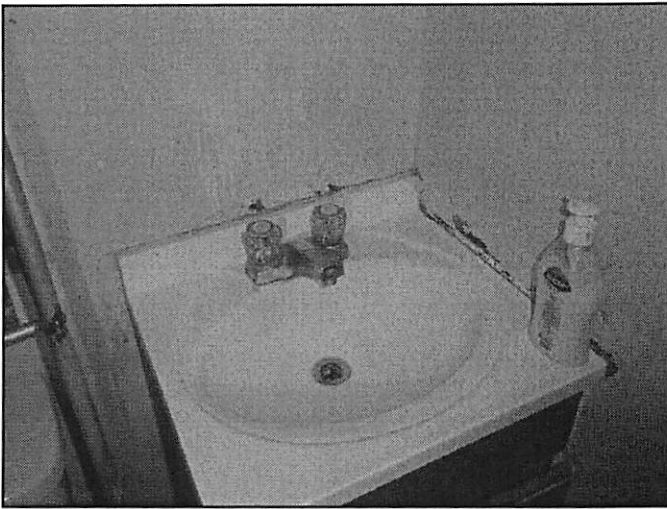
30. Rotten wall around cabinet

Vanity cabinet is deteriorated and wall around is wet & rotten.

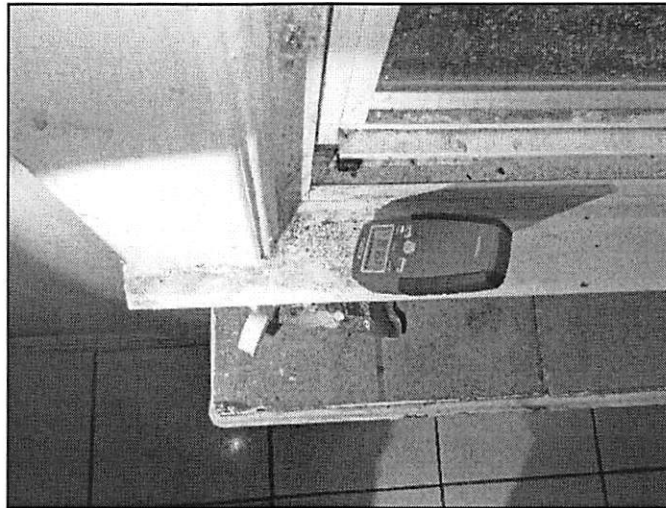
32. Suspected Growth

High moisture and "Suspected Microbial Growth" was found by the window sill.

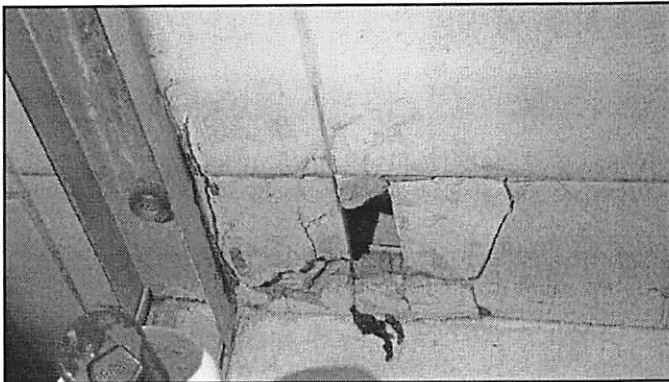
33. Shower wall

25. • The following conditions were noted in the 2nd floor bathroom:  
Medicine cabinet & vanity cabinet are deteriorated and falling apart.  
Outlet is inoperable.  
Wall by the shower is falling apart, tiles are loose and sheetrock behind is wet.  
Floor tiles are cracked and missing .  
Heat convactor is rusty.  
A Licensed contractor should be consulted to remodel this bathroom.

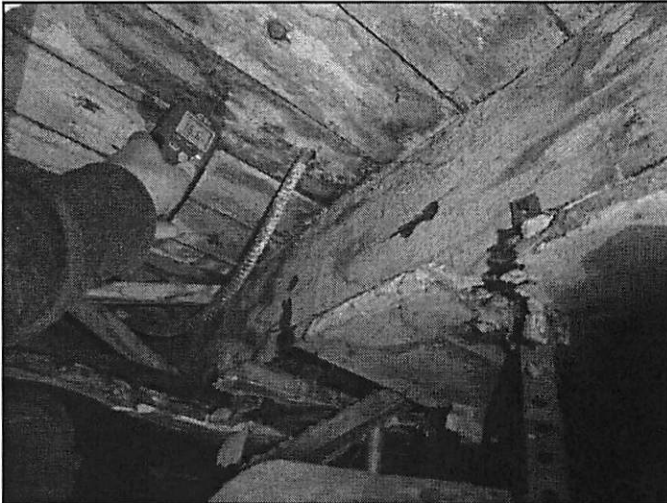
37. Water damage-ceiling basement

#### **26. Condition:** • Water damage

A high level of moisture was detected in basement on sheathing above boiler area. Sheathing in that area is rotten and should be replaced.

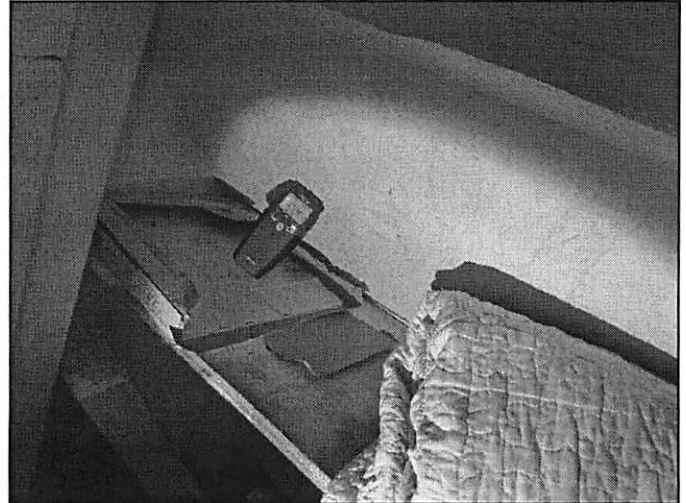
38. Water damage-Attic

High moisture was detected in closet located in the attic. It is most likely that water is coming from the roof which is deteriorated as previously mentioned by Roofing.

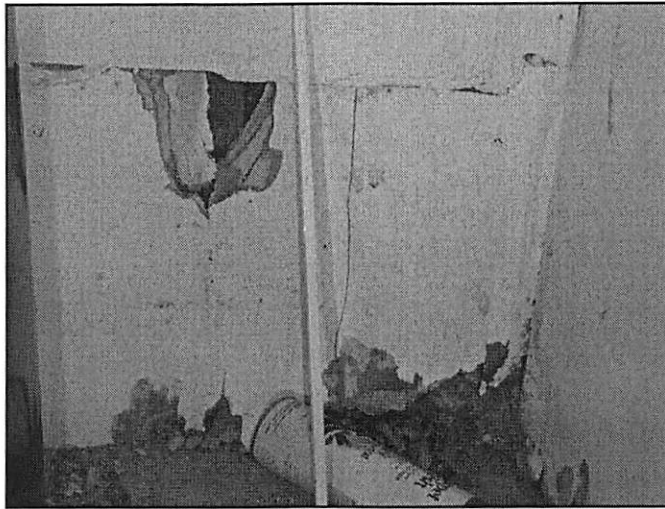
39. Damaged-basement

27. Condition: • Damaged

Sheetrock wall in basement & 2nd floor are damaged and need to be replaced.

Implication(s): Damage or physical injury due to falling materials

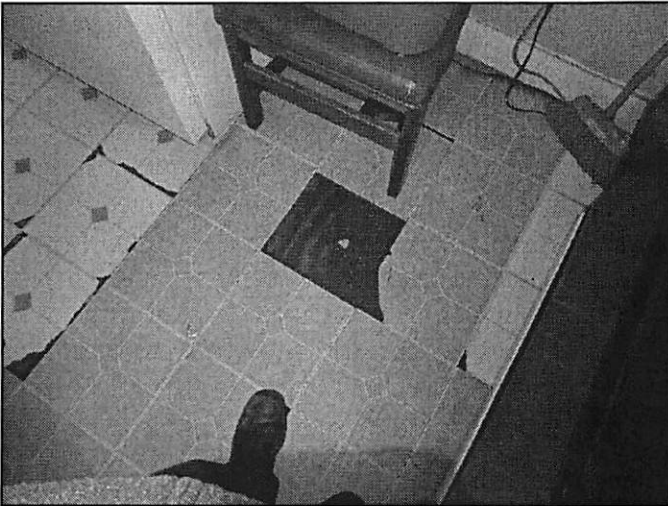
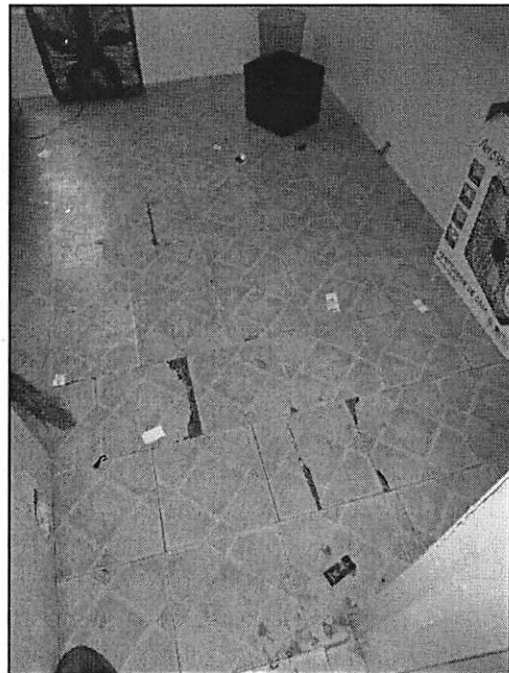
#### 28. Condition: • Damage

Flooring in attic rooms and kitchen are damaged and missing in some areas. Flooring needs to be replaced. Cracked & missing tiles were noted by hallway entrance and kitchen which should be replaced.

**Implication(s):** Material deterioration | Trip or fall hazard

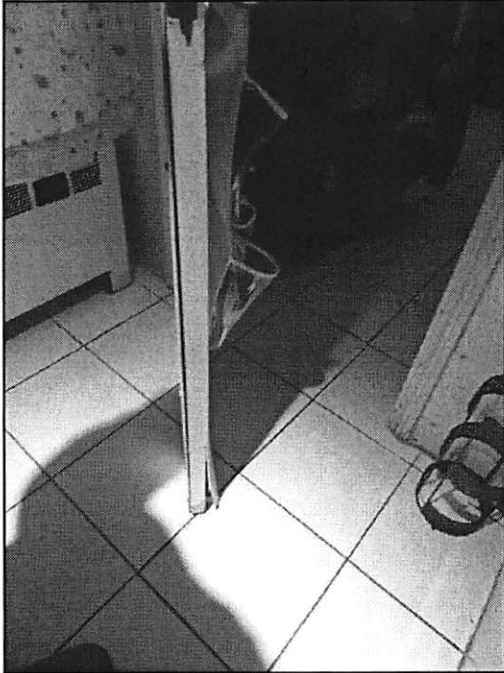
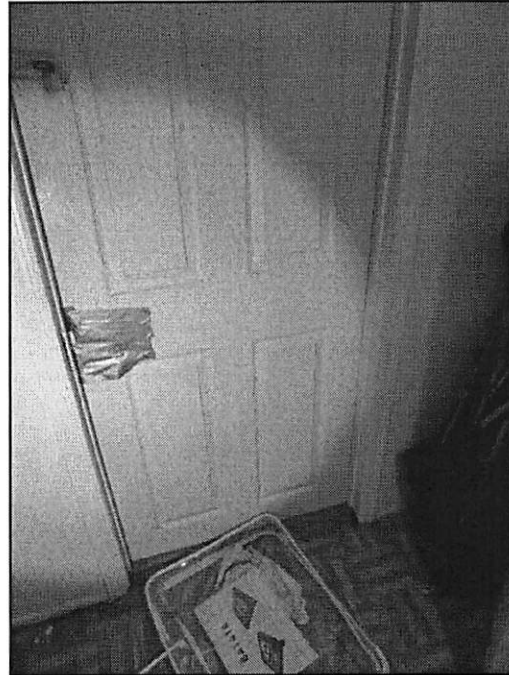
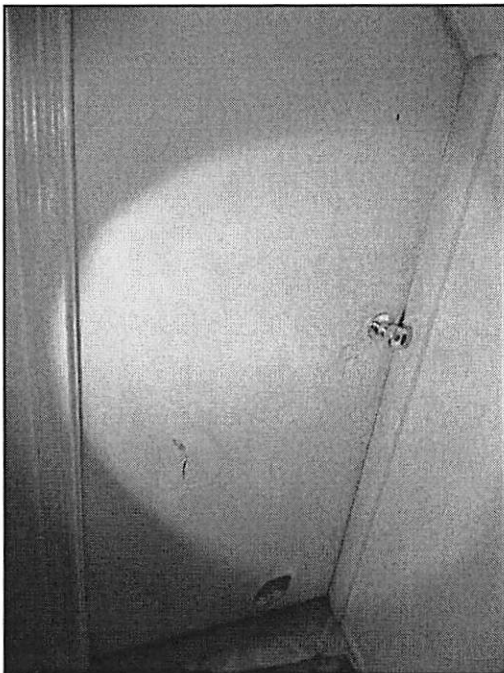
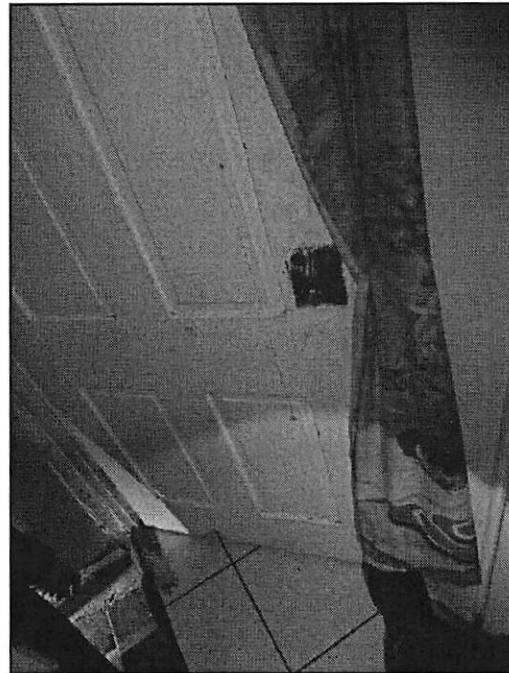
#### 29. Condition: • Damage

Majority of doors in the house are damaged or deteriorated and need to be replaced.

**Implication(s):** Shortened life expectancy of material | Increased heating and cooling costs | Reduced comfort

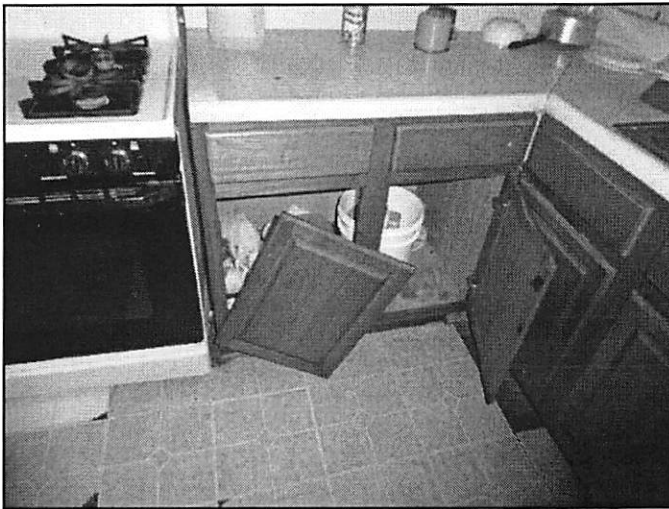
46. Cabinet doors falling apart 2nd fl

Multiple cabinets in kitchen on 2nd floor are falling apart and need to be replaced.

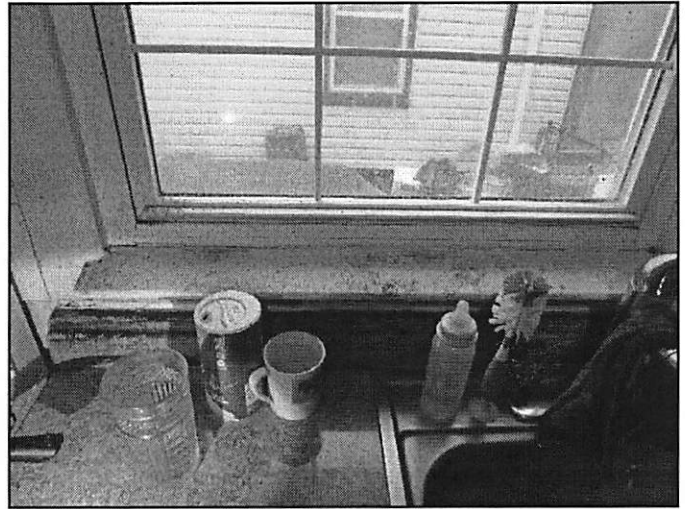
47. Rot-behind sink-1st fl

Counter area and sill behind the kitchen sink on 1st fl is rotted and needs to be replaced.

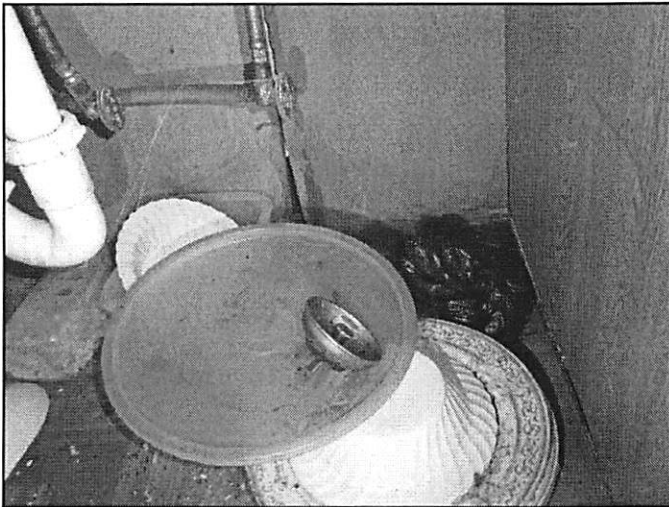
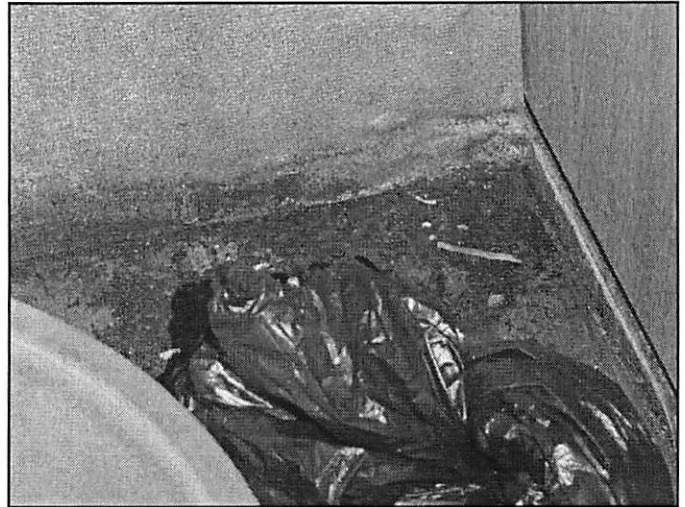
2nd fl kitchen cabinet floor under sink is rotten and damaged. Leak should be further investigated and corrected and cabinet replaced.

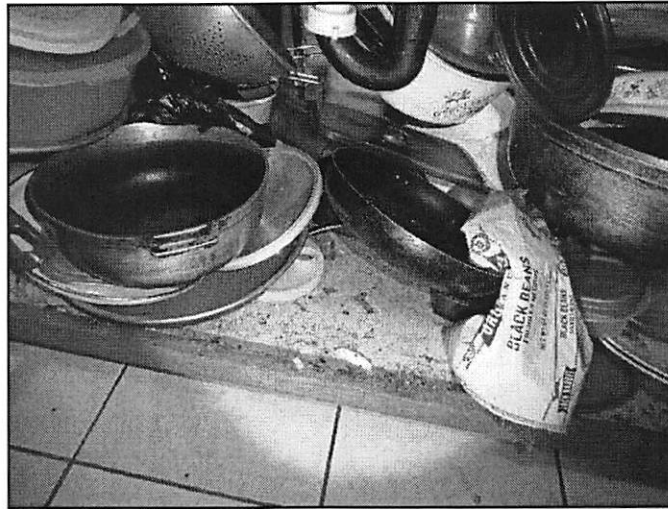
50. Deteriorated cabinet-1st fl

1st floor kitchen cabinet floor in is deteriorated and needs to be replaced.

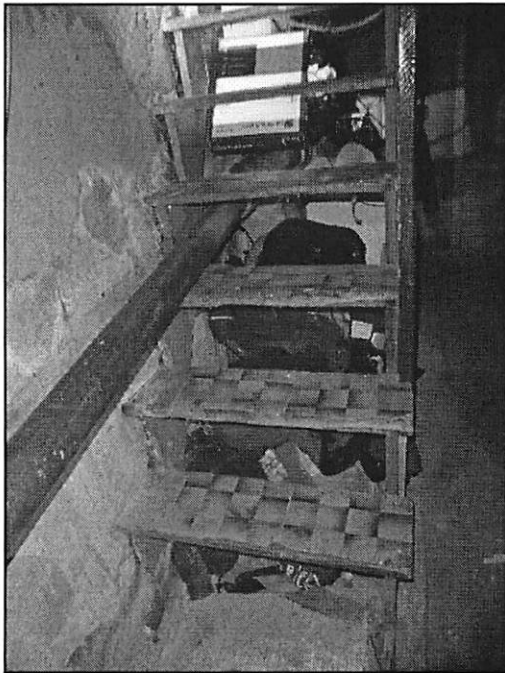
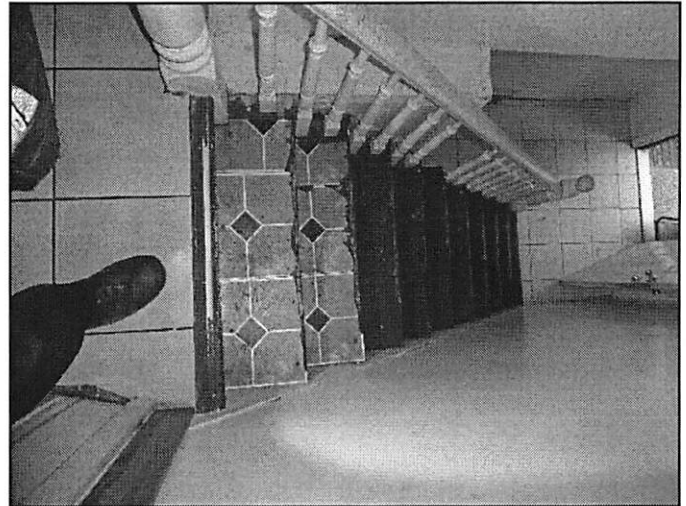
**31. Condition:** • All three staircases in the house need to be redone due to poorly built/deterioration which makes it unsafe.

Railing by one of the staircases are loose.

**Implication(s):** physical injury
